# **VOC Detection in an Industrial Estate, UK**

#### **APPLICATION**

Monitoring of the drains at 6 different points to detect accidents and spillages.

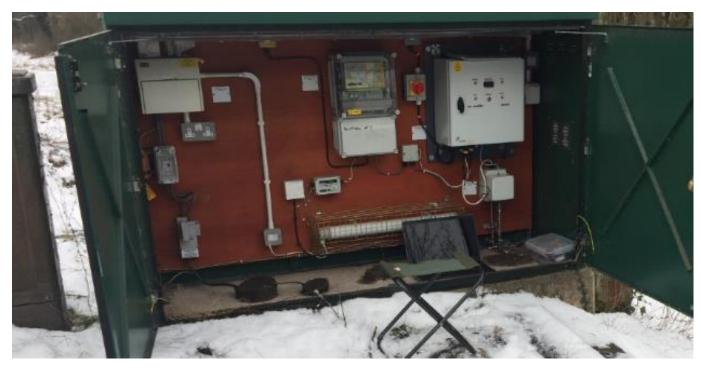
Unit installed in a cabinet. There are 6 of these cabinets on the industrial estate and include heating system, lighting protection and connection to the telemetry system.

Air is drawn from the drain via a fan into the analyzer. The system detects spillages. An interesting instance was when an adhesives manufacturer discharging high levels of

MS1000, replaced by MS1200-AIR with 4-20 mA output to telemetry and a fan system to draw air from the drain.
